FINAL REPORT

THE EVALUATION OF A TIN-ALUMINIDE OXIDATION
RESISTANT COATING FOR REACTION CONTROL SYSTEM
THRUST SYSTEMS APPLICATIONS

TMC Report No. S-430

CONTRACT NO.: NAS 9-1765

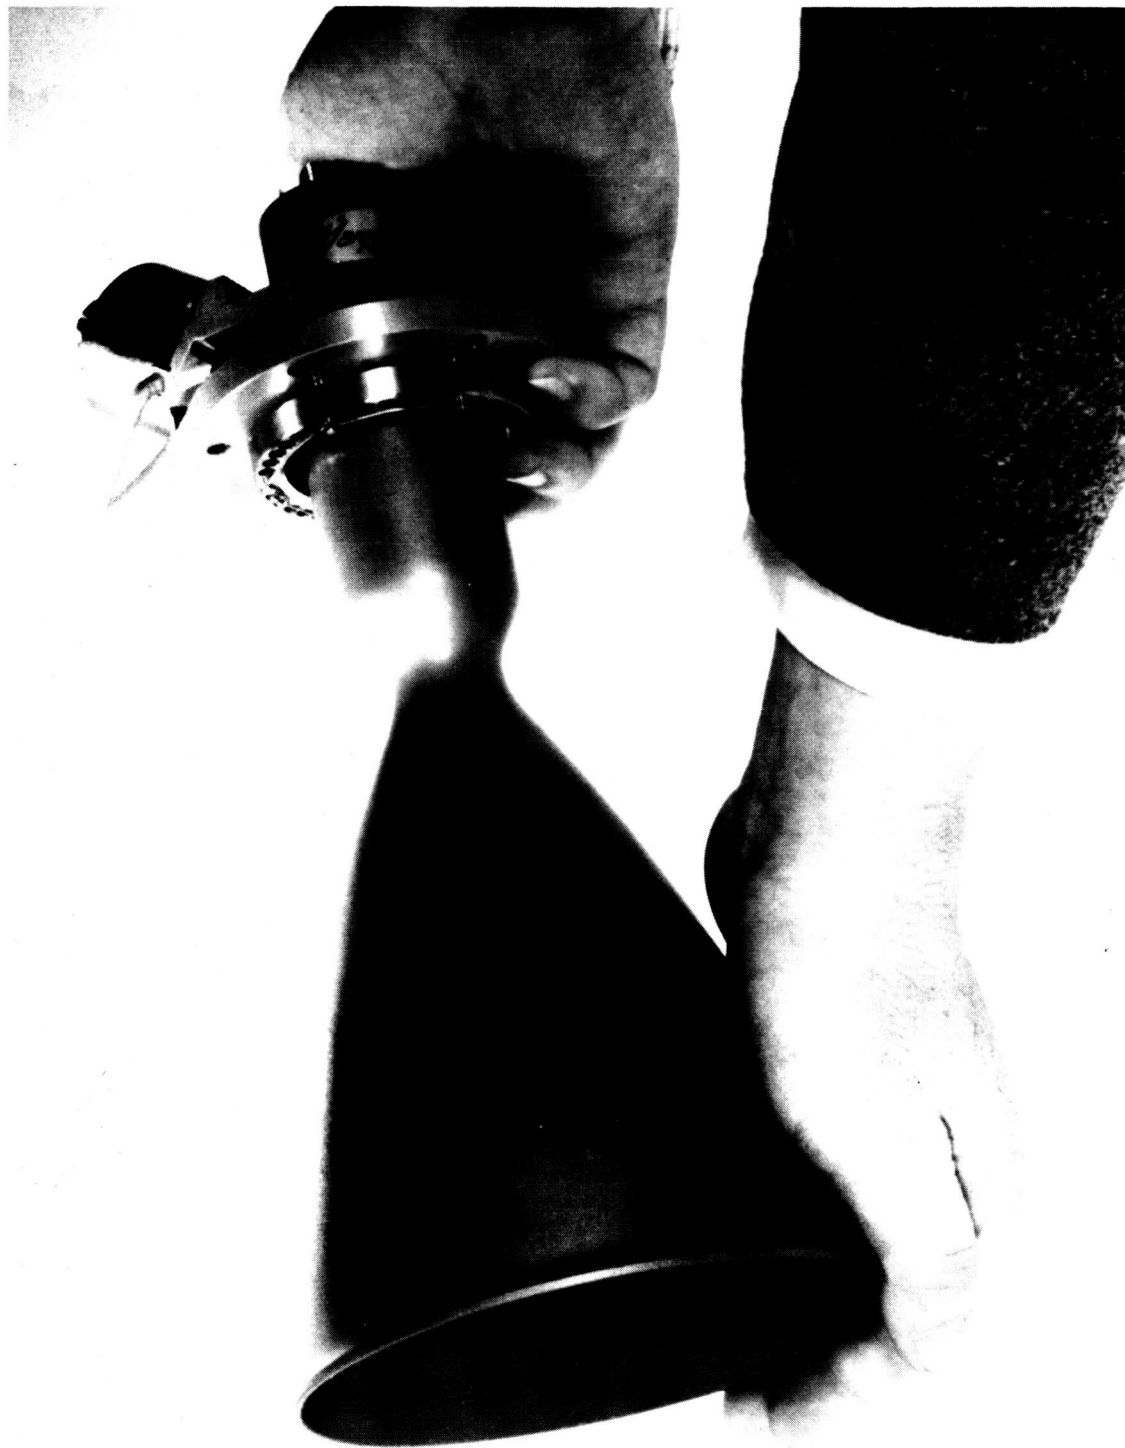
FIGURE 1

100 POUND THRUST RADIATION COOLED REACTION CONTROL ROCKET ENGINE ASSEMBLY

An investigation of 90Ta-10W material, coated with an oxidation resistant tin-aluminide coating was conducted. The study was oriented toward the typical thrust chamber designs and operation conditions that prevail in the Apollo Service Module (S/M) Reaction Control System (RCS), which includes thrust chambers and propellant injection system (for purposes of this discussion). A photograph of this typical radiation cooled thrust chamber assembly, which includes propellant injection head and propellant valves is presented in Figure (1).

The hardware experimentally studied has the same general appearance as shown in the photograph of Figure (1). The significant difference in the thrust chambers tested is the wall thickness. The wall thickness variation is shown in Figure (2) as a function of cross sectional area of metal for the chamber length. A basic reference used was the Apollo S/M RCS molybdenum chamber (P/N 225864) which had been experimentally operated with a wide range of propellant injector designs and which also represents a typical Apollo design. The full length of an Apollo chamber skirt is 6.984 inches (throat measured along the axial centerline to exit dimension), however, wall thickness is shown to only the 5 inch length in Figure (2) since this length fully covers the region of interest. A schematic of the basic molybdenum reference chamber (P/N 225864), the "thin wall" 90Ta-10W chamber (P/N X-18920), and the "thick wall" 90Ta-10W chamber (P/N MD1141) is presented in Figure (3) as a supplement to Figure (2).

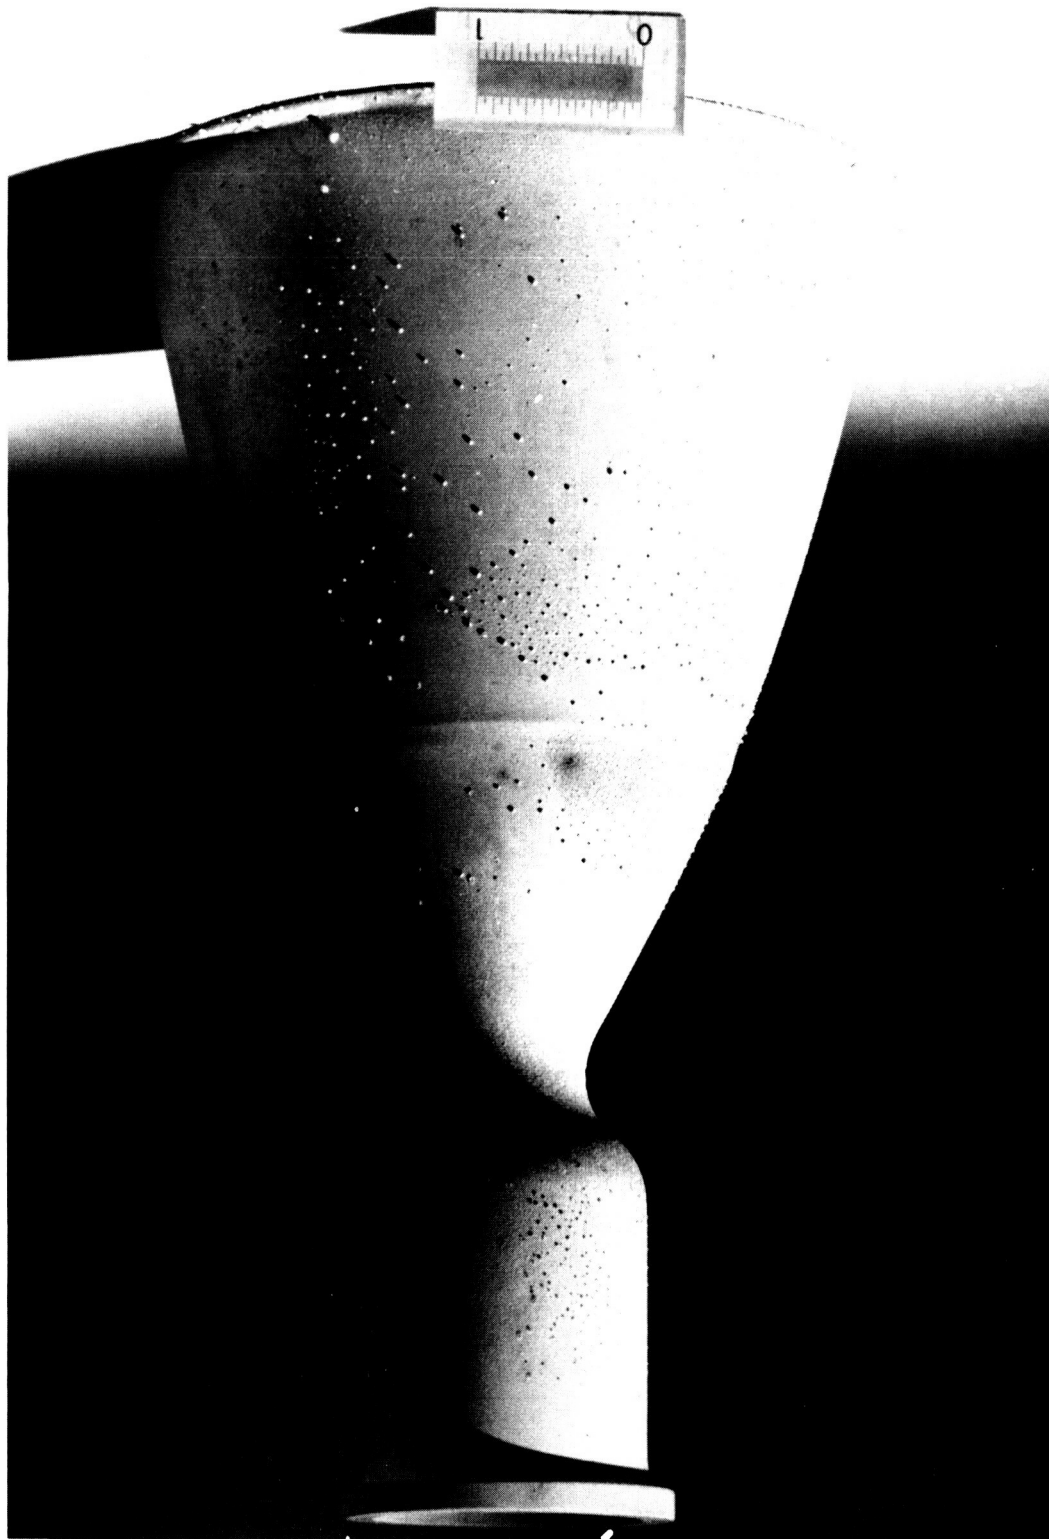
THRUST CHAMBER X18920 90Ta-10W TIN ALUMINIDE COATED

BEFORE ROCKET FIRING

This chamber was designed with structural strength as a primary criteria. Reference to Figure (2) shows that this chamber, while structurally sound, has a significantly smaller cross sectional area of metal. A photograph of the chamber after tin-aluminide coating was applied by General Telephone & Electronics Laboratories is presented in Figure (4). The excess coating formed spheres on the chamber, both on the interior and the exterior surfaces as depicted in the photograph. These "balls" of excess tin and aluminum were formed when the chamber was furnace conditioned

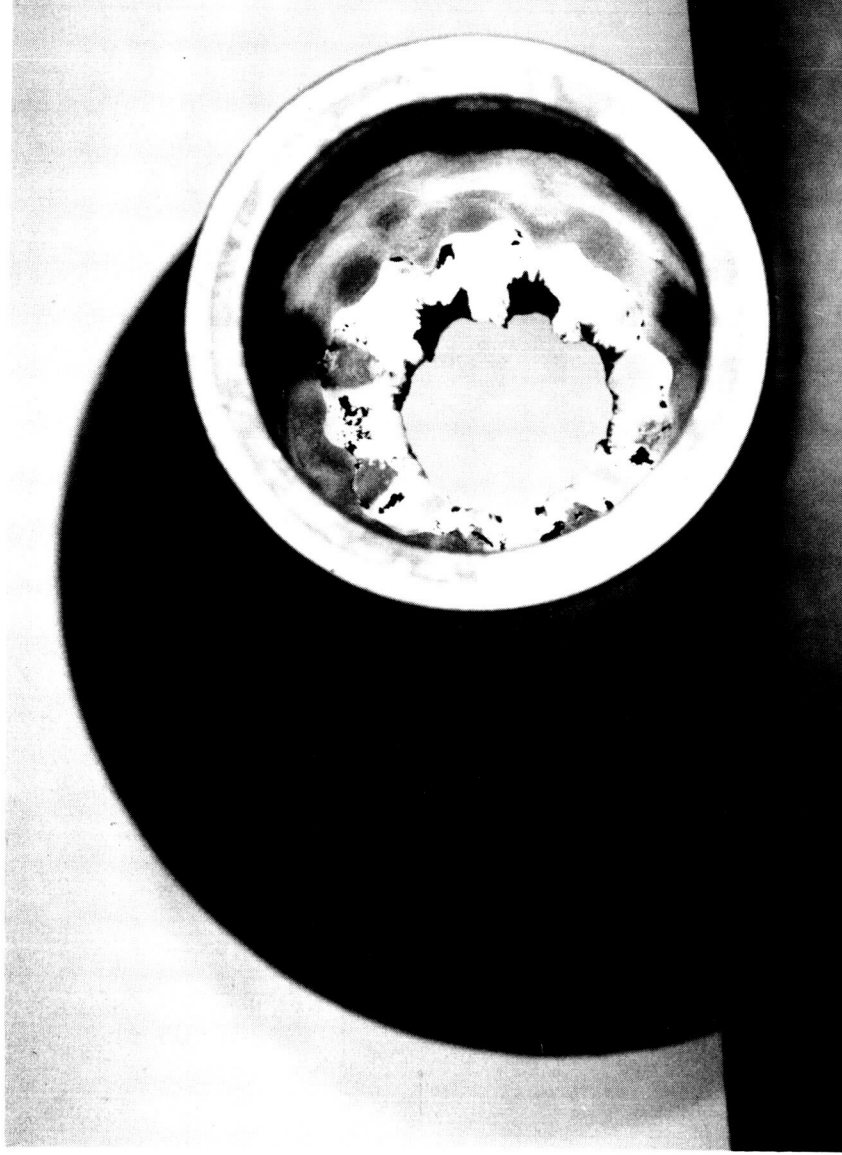
THRUST CHAMBER MD1141 S/N-2 90Ta-10W TIN ALUMINIDE COATED

ENGINE ASSEMBLY T10060 SHOWN AFTER 7972 SECONDS OPERATION

The coating on the exterior of the chamber was observed to apparently fail near the end of the first test run of 3815 seconds, based on a review of motion picture coverage of the experiment. The coating on the throat interior appeared to withstand the temperature-scrubbing environment through a total of approximately 2 hours at chamber throat temperatures that did not exceed 2460°F. A change in O/F ratio and a subsequent increase in throat temperature to 2750°F resulted in a failure of the coating in 137 additional seconds of testing. Three (3) photographs of the chamber, taken after failure, are presented in Figures (9), (10), and (11) for respective views of the chamber exteriors, inlet end, and exit bell.

The loss of coating on the exterior of the chamber is noted in Figure (9). The relatively uniform failure of the coating in this internal throat area is depicted in the respective end views of the chamber in Figures (10) and (11). The variation, or erosion, of the throat area is shown in Figure (12). The analysis used to prepare Figure (12) is identical to that described for chamber P/N X-18920. The failure pattern appears to be quite similar to that observed in the P/N X-18920 chamber when compared to the rate of throat erosion in the final seconds of chamber operation.

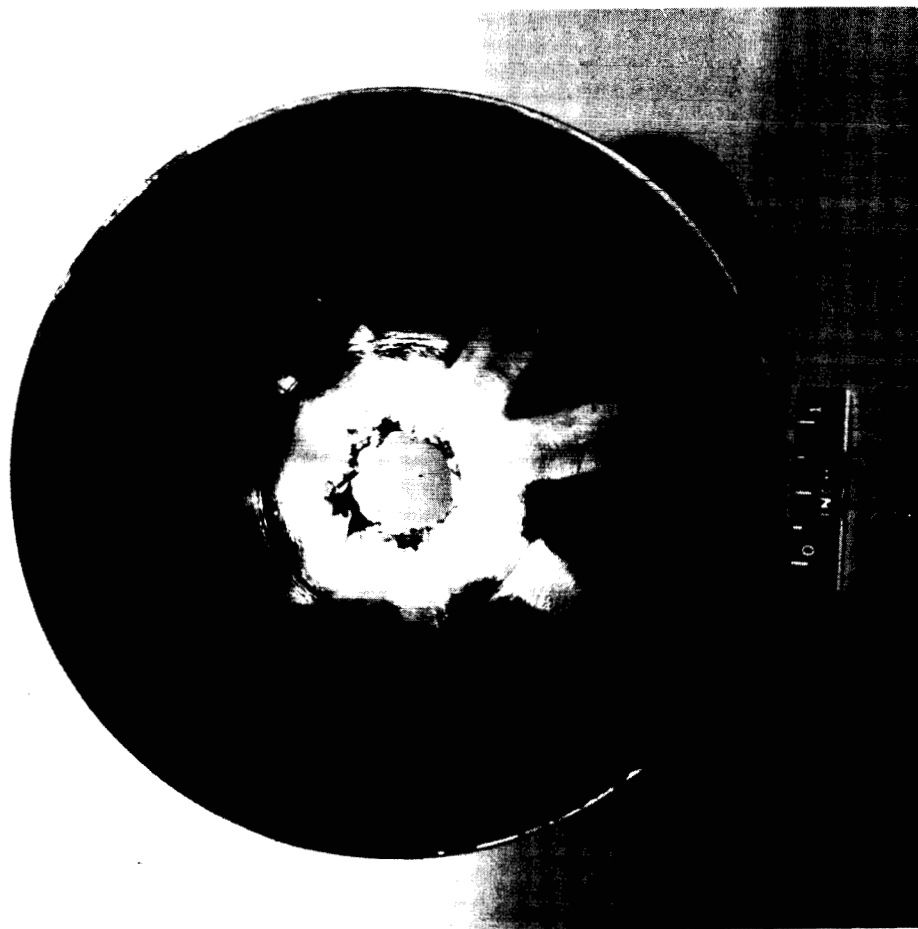
FIGURE 11

THRUST CHAMBER MD1141 S/N-2 90Ta-10W TIN ALUMINIDE COATED

ENGINE ASSEMBLY T10060 SHOWN AFTER 7972 SECONDS OPERATION

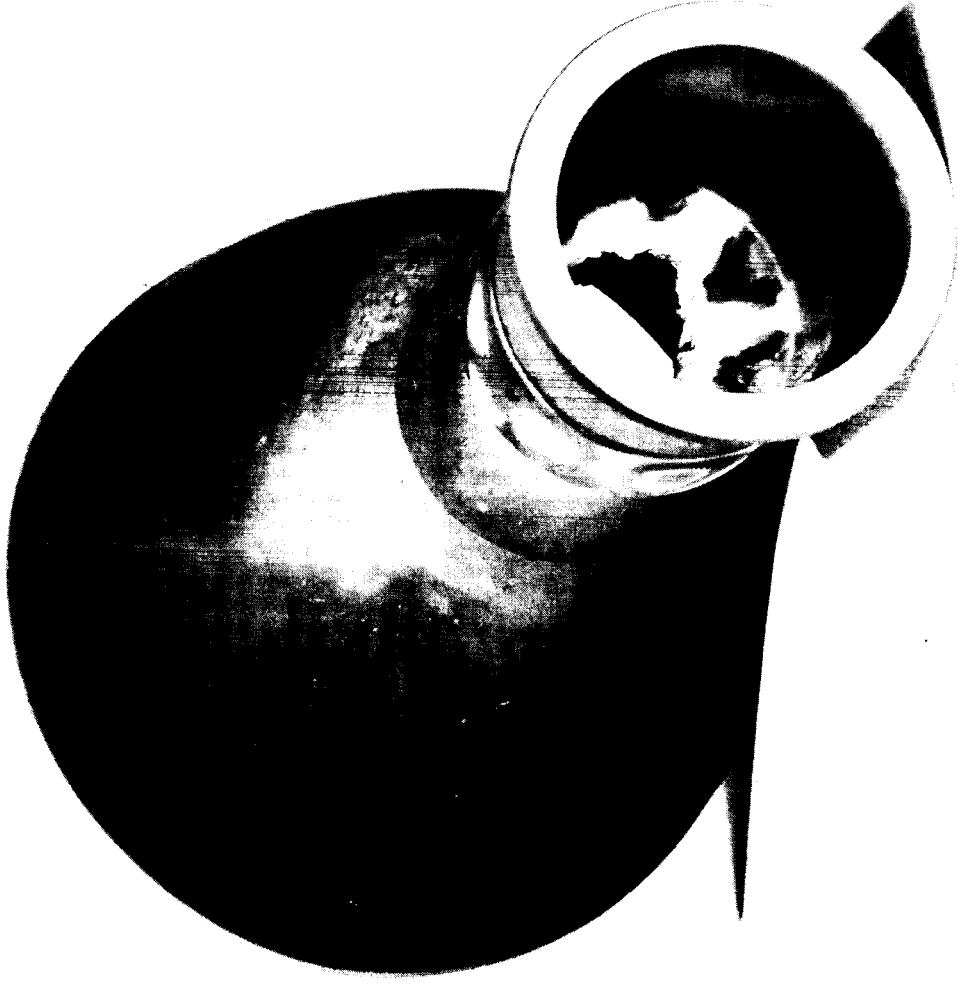
FIGURE 14

THRUST CHAMBER MD1141 S/N-1 90Ta-10W DISILICIDE COATED

ENGINE ASSEMBLY T10060 SHOWN AFTER 11553 SECONDS OPERATION

The chamber was disilicide coated by the Chromizing Company's MGF coating. The specified coating thickness was 0.0015" - 0.0025". The experiments were conducted with the T-10060 engine assembly (T-8240 injector head) and are summarized and tabulated below. A range of O/F ratio was covered to increase the throat temperature above that normally encountered (2300°F). A test run @ 2600°F was initiated after a cumulative running time of greater than 2 hours. Failure of the coating occurred during the 2600°F test run after approximately 57 minutes of steady-state rocket operation at this throat temperature. Photographs of the chamber, showing the coating failure mode are presented in Figures (13), (14), and (15).

The metallographic examination revealed that the failure occurred through deterioration or breakdown of the coating and subsequent oxidation of the base metal. A section through one of the yellow oxidized areas, half way down the length of the chamber, showed a break developing in the coating and samples taken in the throat show later stages of oxidation. Temperature effects were negligible in the flange region.

The metallographic examination revealed that coating failure occurred by erosion and pitting, allowing the oxidizing atmosphere to reach the base metal. Oxidation of the base metal then progressed rapidly inwards and longitudinally under intact portions of the coating.

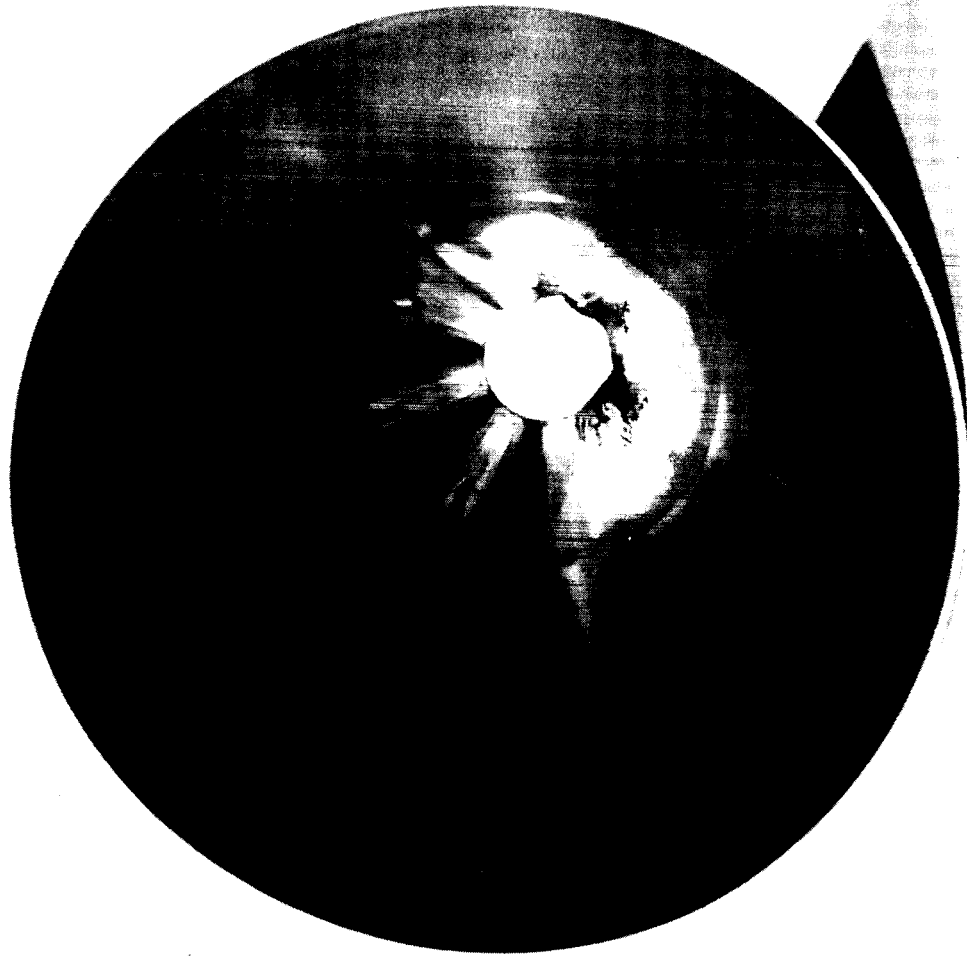
FIGURE 15

**THRUST CHAMBER MD 1141 S/N-1
90Ta -10W DISILICIDE COATED**

ENGINE ASSEMBLY T10060 SHOWN AFTER 11553 SECONDS OPERATION

The coating loss in this chamber throat differs in comparison to the tin-aluminide in that coating failure appears to be local, rather than across a complete cross section. Minor differences in coating thickness could result in a more rapid local failure which may be indicated by the streaks observed on the chamber. The streaks appear to be a result of final coating breakdown, with resultant feathered viscous glass flow into the exit bell.
